# NATIONAL BUREAU OF STANDARDS REPORT

8975

## Investigation of Performance Characteristics for Sanitary Plumbing Fixtures

Building Research Division  
Institute for Applied Technology

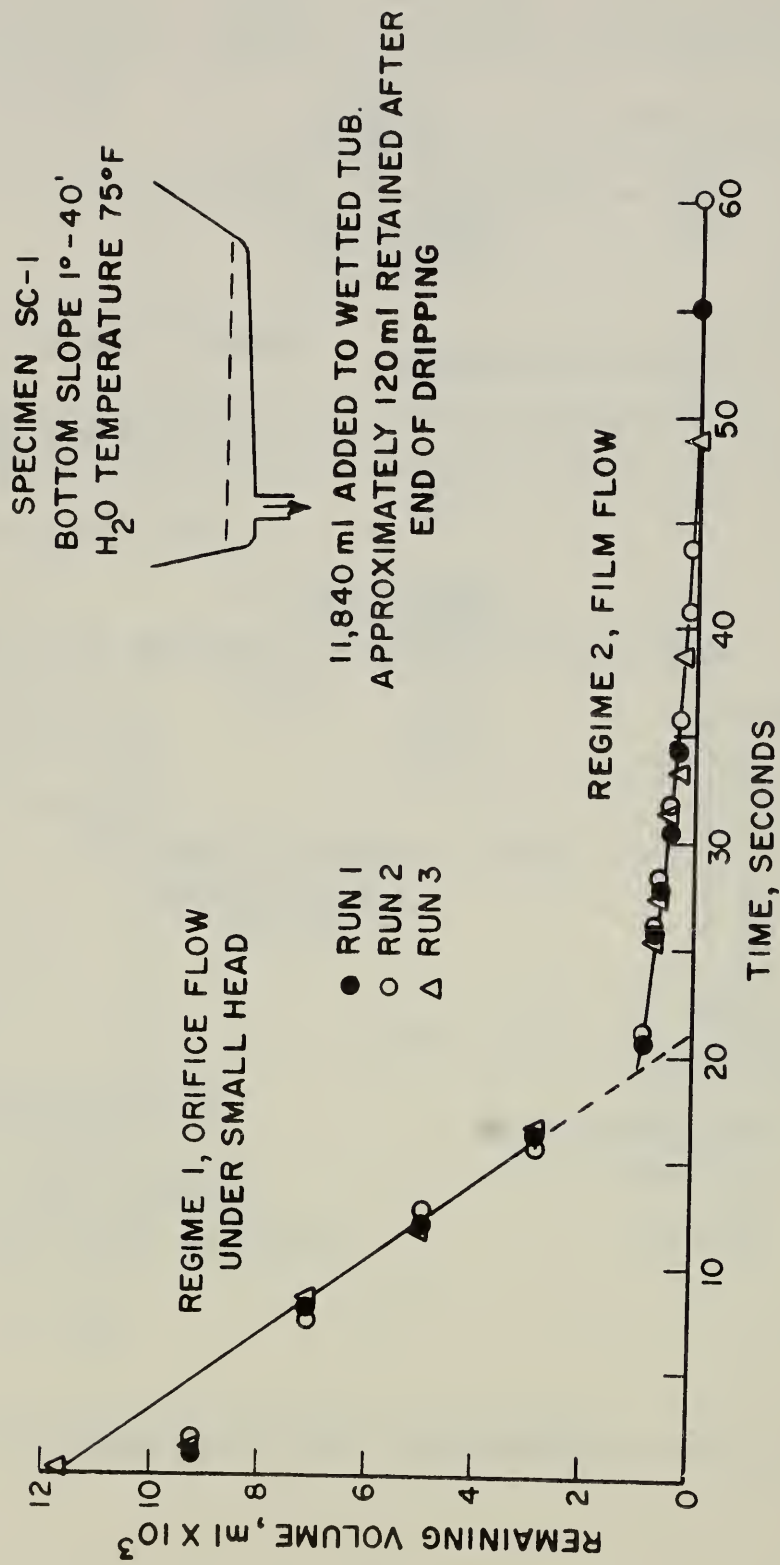
FIG.2.17-2 —DISCHARGE PATTERN FOR BATHTUB

SPECIMEN SC-1  
 11,840 ml ADDED TO WETTED TUB  
 H<sub>2</sub>O TEMPERATURE 76°F

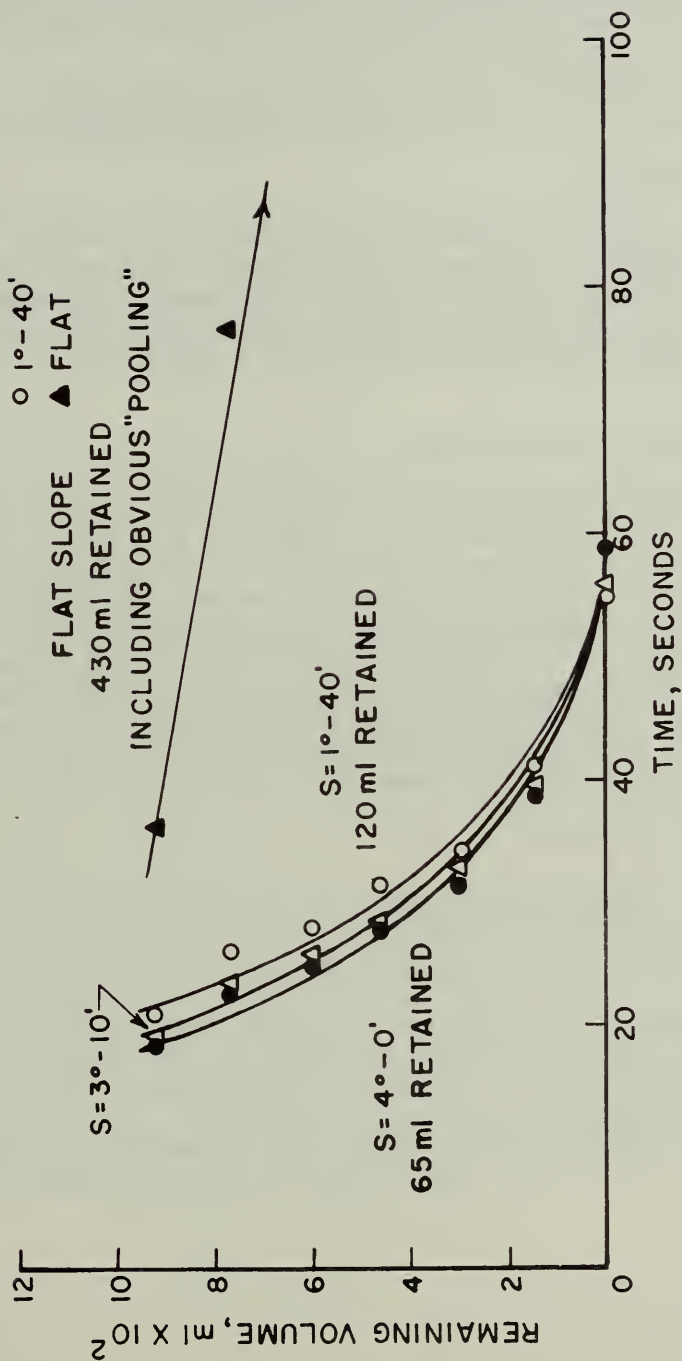
FIG. 2.17-3 — BOTTOM SLOPE EFFECT IN BATHTUB DRAINAGE TEST, REGIME 2

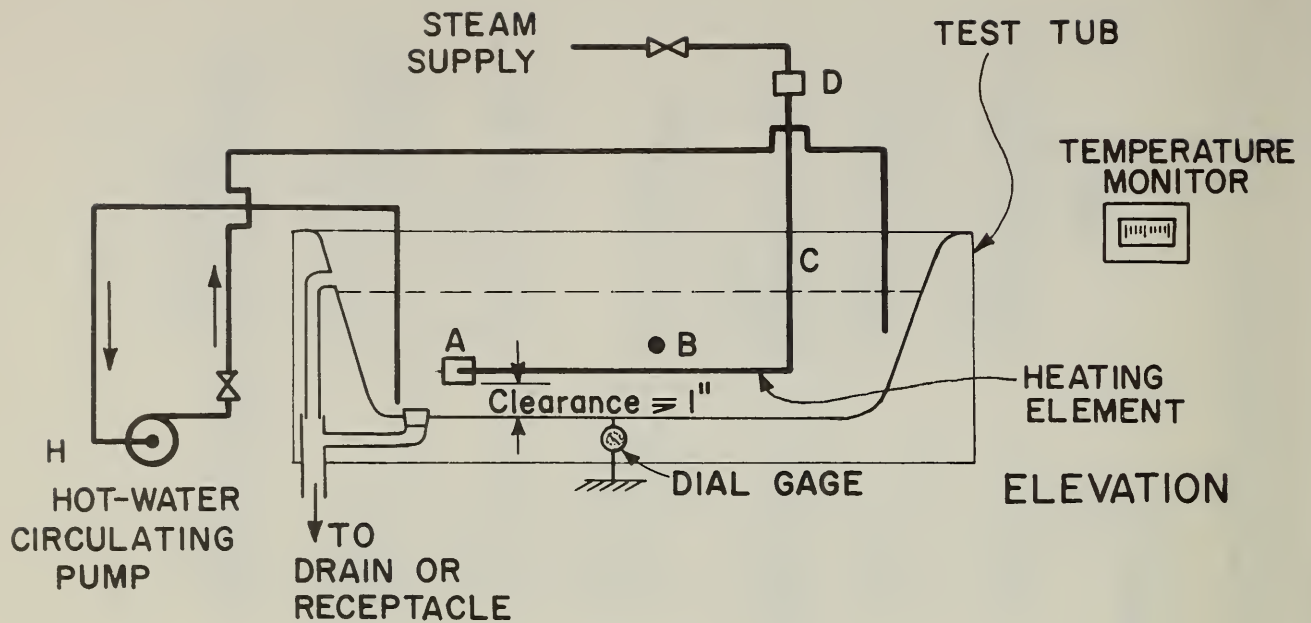
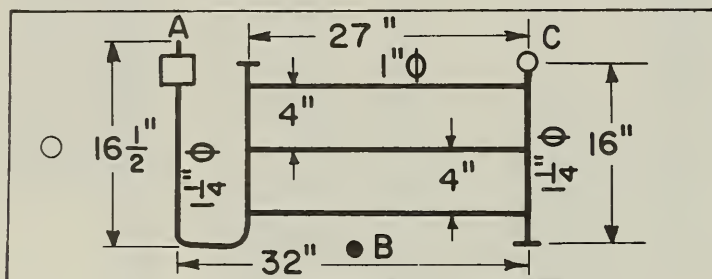
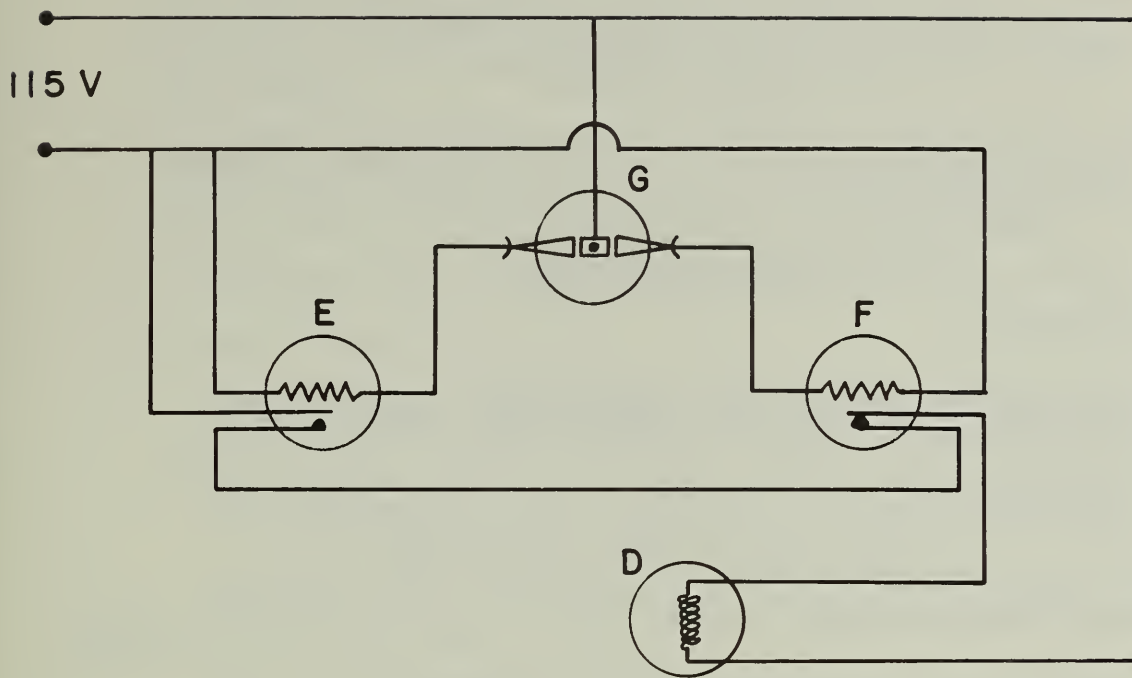
#### PLACEMENT AND DIMENSIONS OF HEATING ELEMENT IN TEST TUB

MATERIAL: Type L Copper Water Tube

- A. Steam Trap Safe for Use at Line Pressure --Opens to Discharge Condensate into Test Tub
- B. Thermostat and Recorder Sensor Location Approx, Mid-depth and Mid-length, 2" to 4" from Wall
- C. Riser, 3/4" Copper or Brass Pipe
- D. Solenoid Operated Steam Valve, Nominal 3/4" Dia.
- H. Pump Capable of Circulating 10 gpm through Suction and Discharge Lines.

FIG. 2.18-1 APPARATUS FOR HOT WATER RESISTANCE TEST.

D - SOLENOID OPERATED STEAM VALVE, NOMINAL 1" DIA.

E - 45 SEC. TIME DELAY RELAY, CONTACTS N.O.

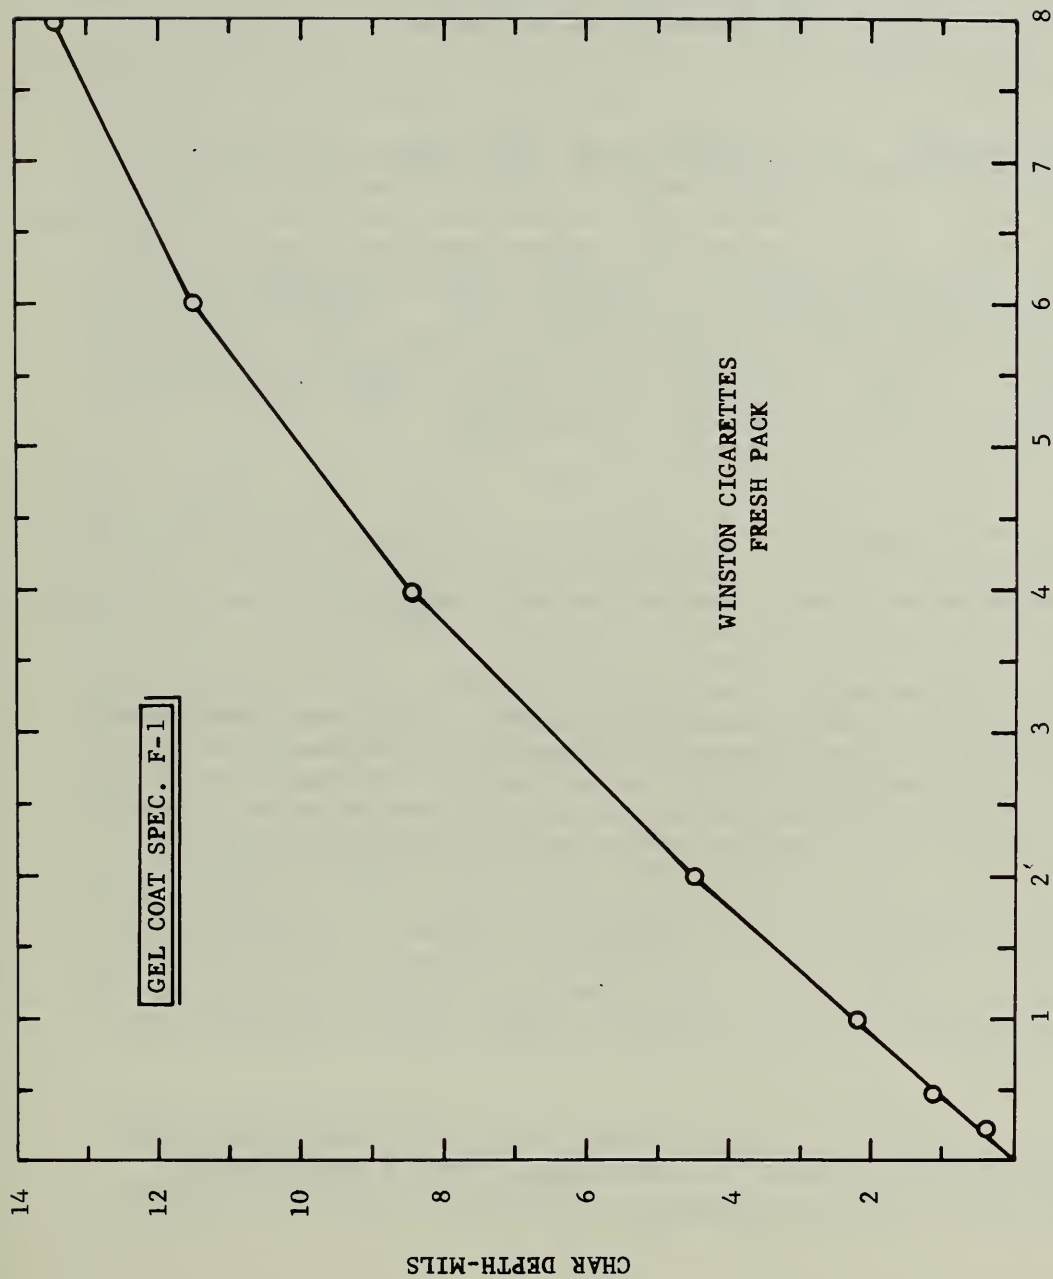
Fig. 2.19-1 Char Depths for a 22-Mil Polyester Gel Coat on a 0.10-in. Fiber Glass-Resin Backing

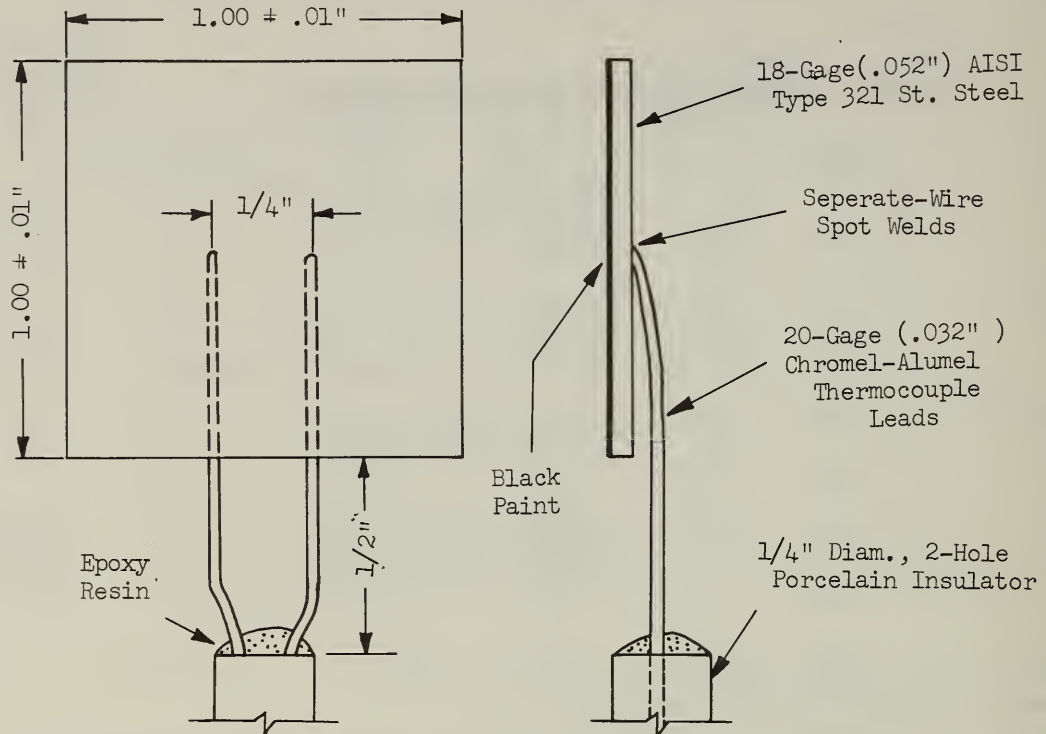
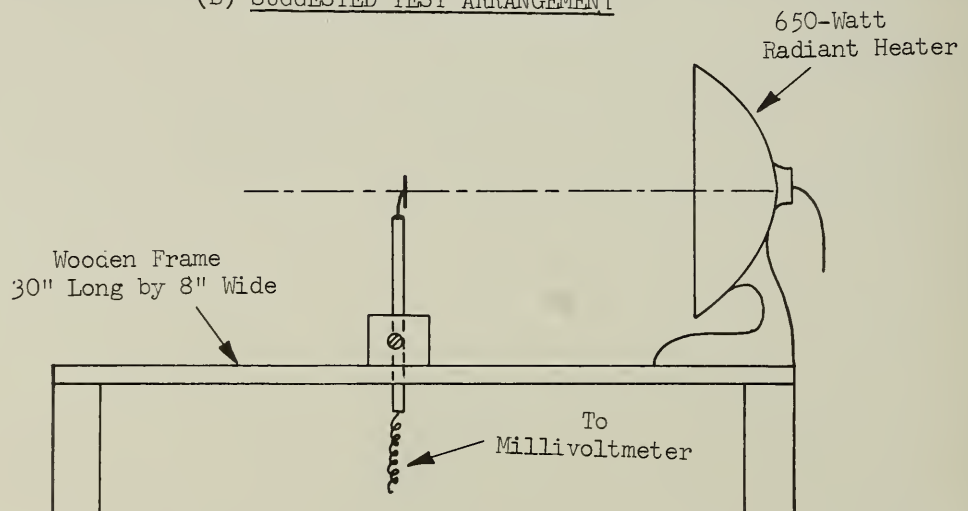
(A) BLACK-PANEL RADIOMETER

Note: Black paint to be sprayed to a thickness of 0.002". Abrade surface prior to spraying with 400C silicon carbide paper.

(B) SUGGESTED TEST ARRANGEMENT

Figure 20-1. Black-panel radiometer probe and suggested arrangement for calibration of radiant heater.

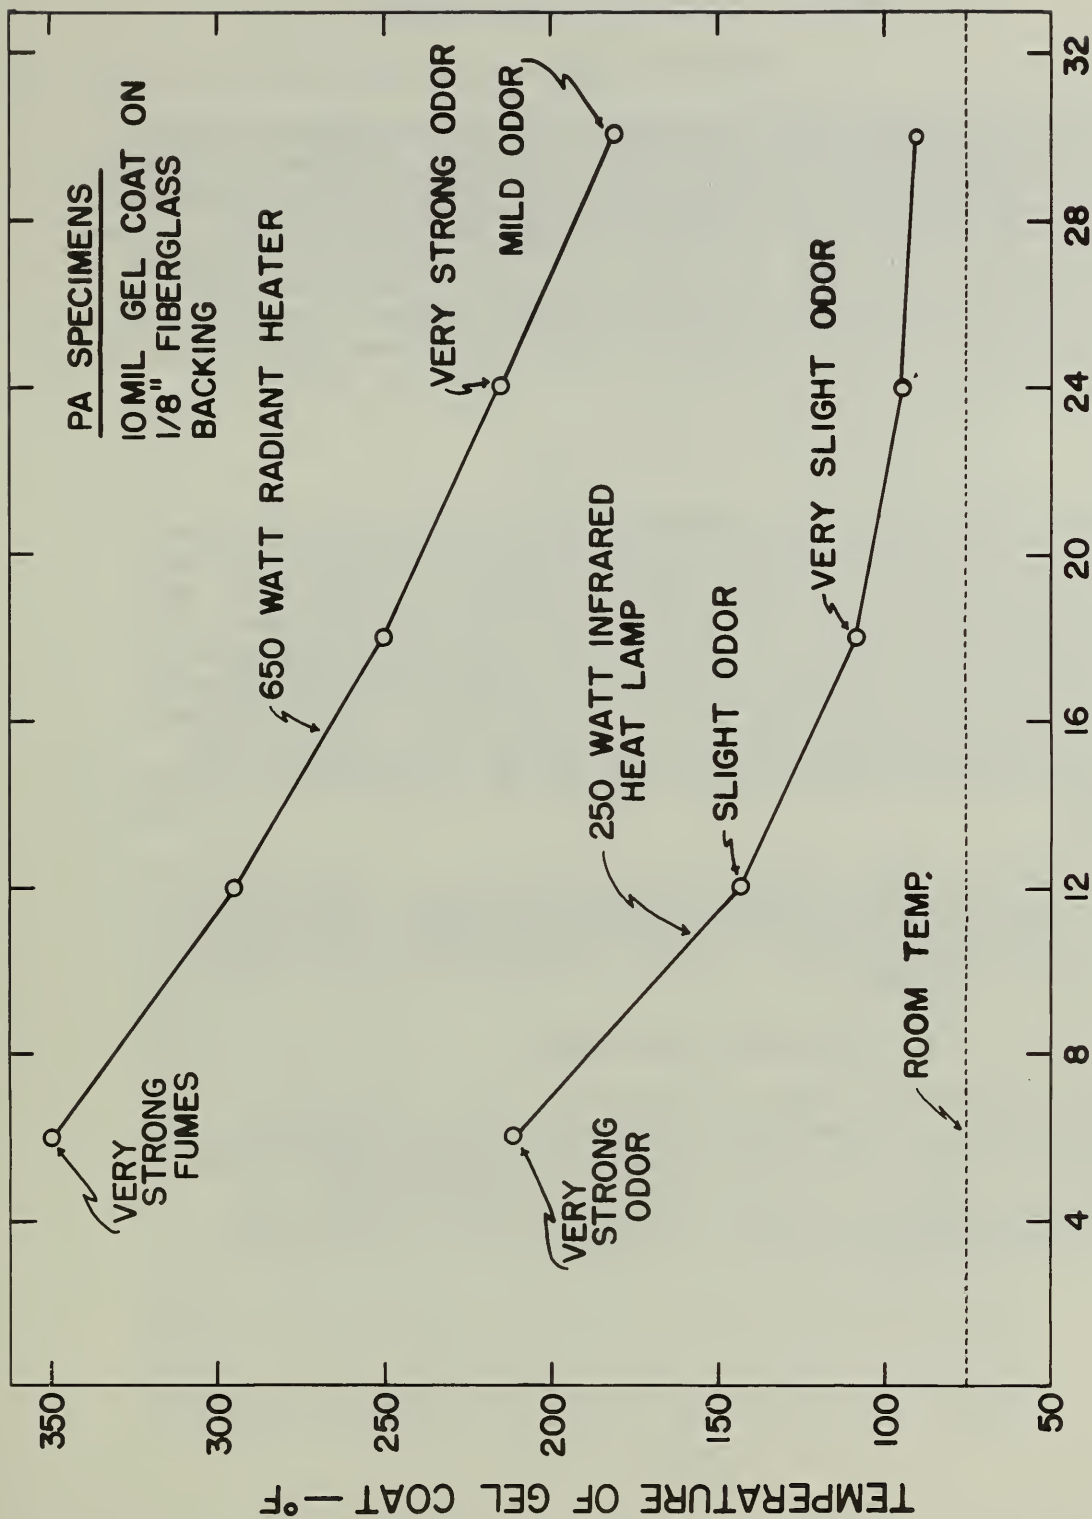
Figure 2.20-2. Results of preliminary radiant-heater with 4-in. square specimens.

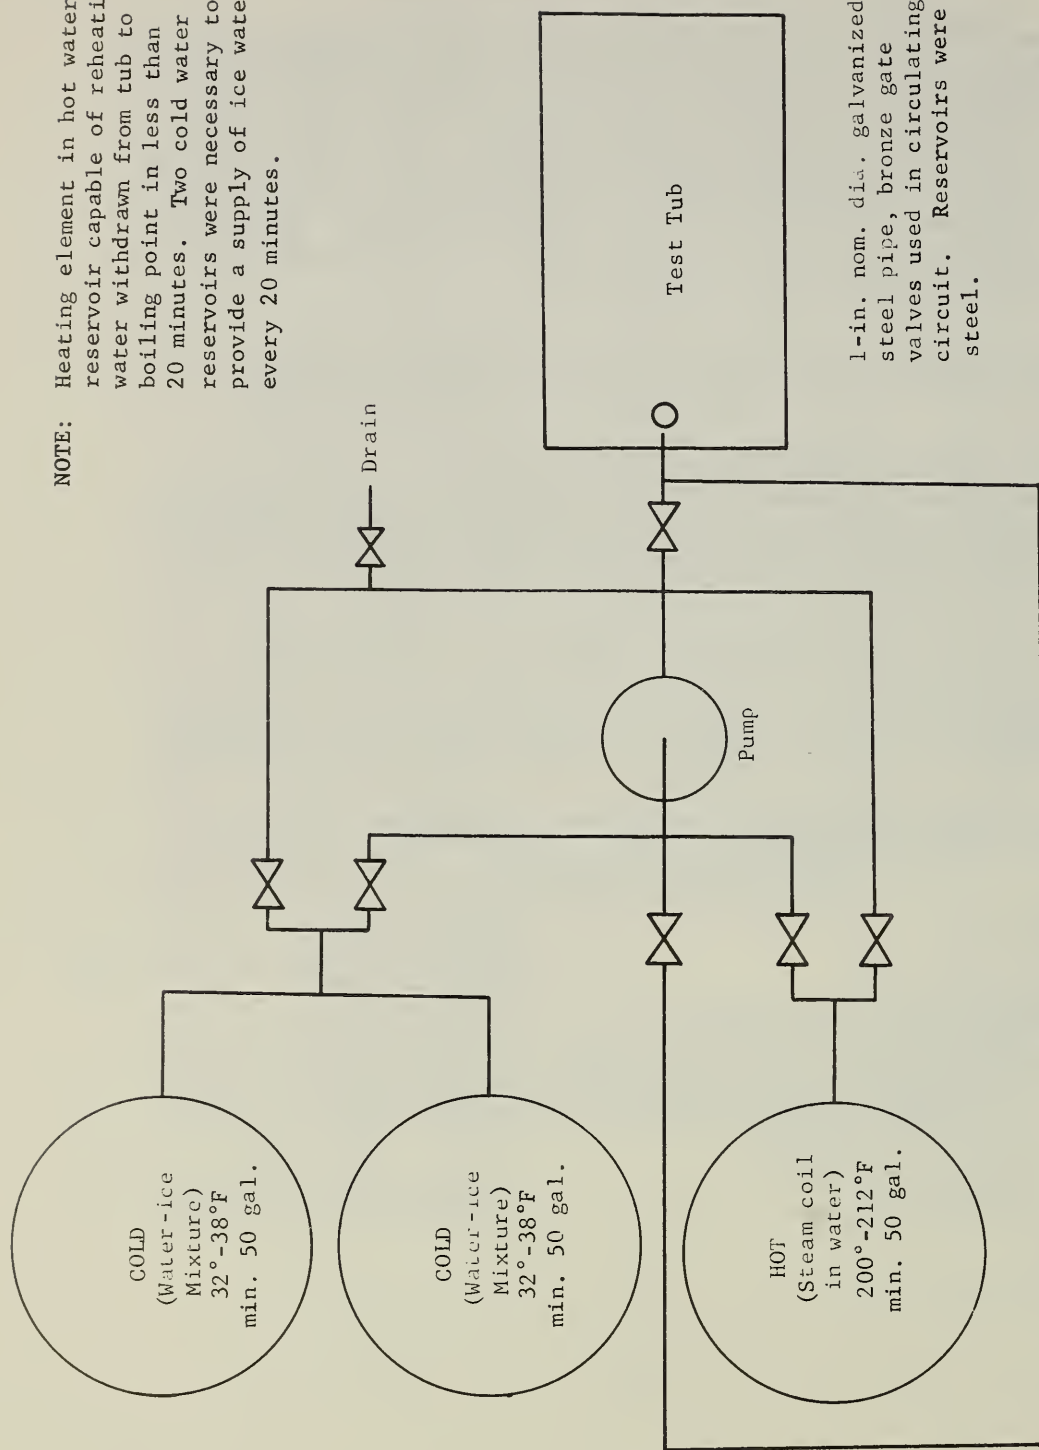
NOTE: Heating element in hot water reservoir capable of reheating water withdrawn from tub to boiling point in less than 20 minutes. Two cold water reservoirs were necessary to provide a supply of ice water every 20 minutes.

Figure 2.21-1. Schematic of Thermal Shock Test Apparatus for Complete Bathtub

<sup>1/</sup> See Fig. 2.21-1

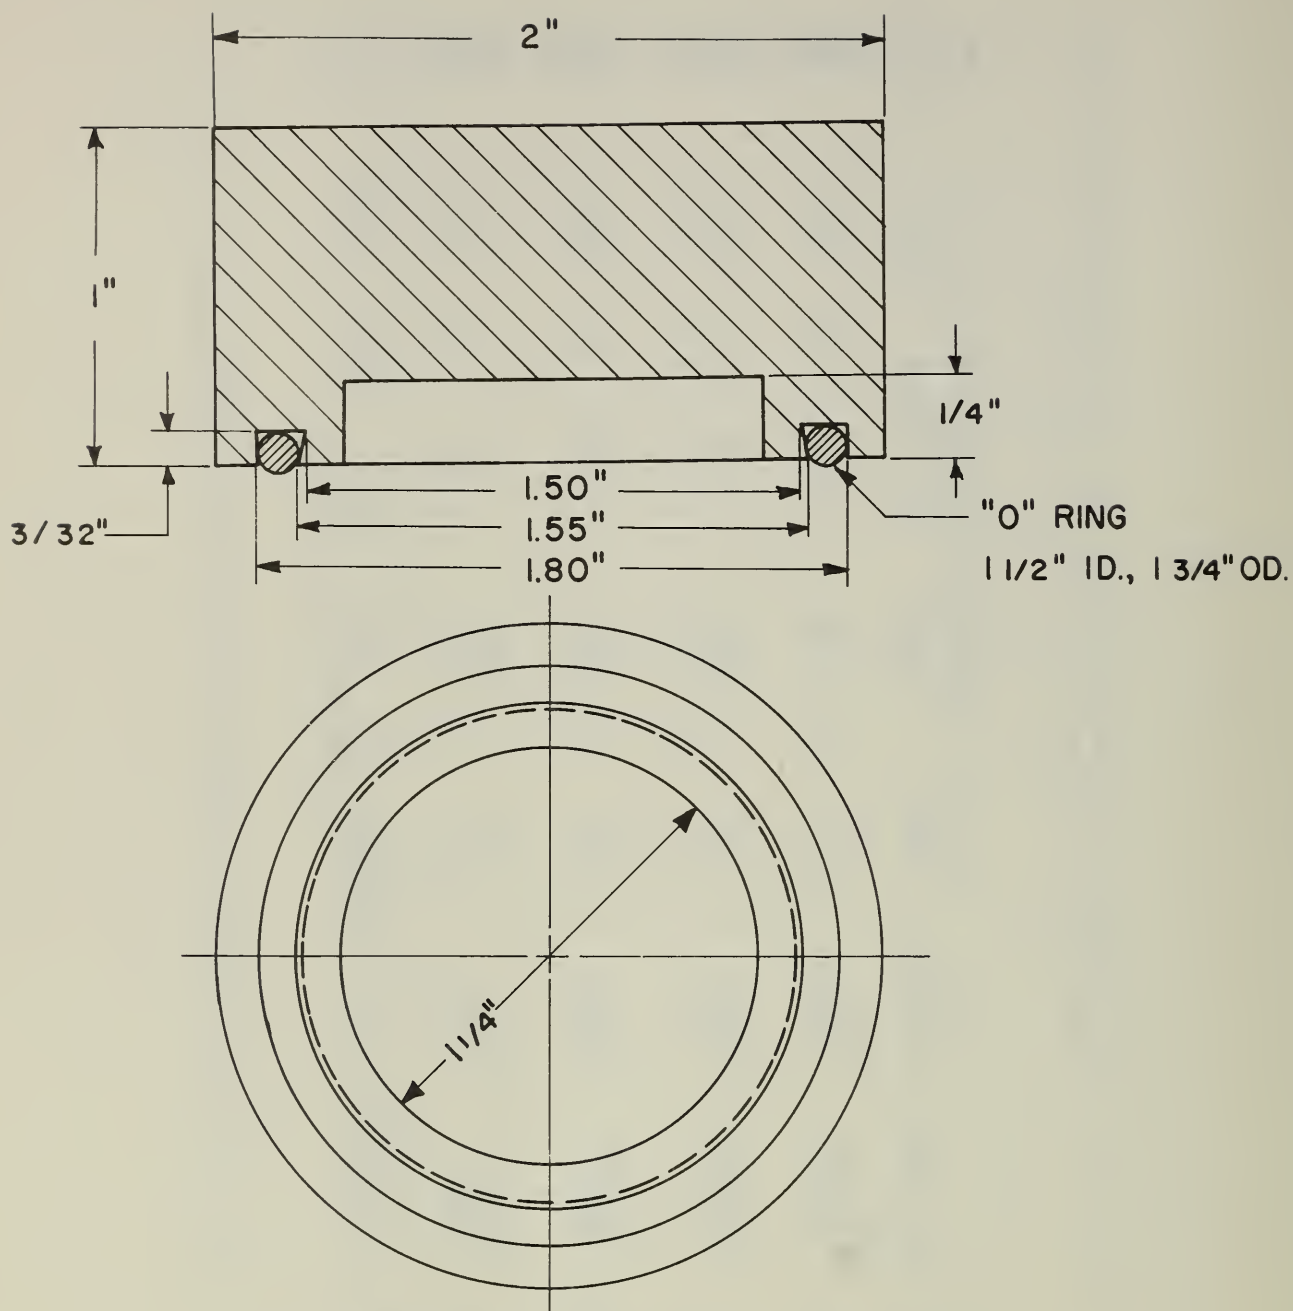
Fig. 2.23-1 Brass cover block for stain testing
